# 8<sup>TH</sup> ARMY AVIATION TRAINING INFORMATION

**PURPOSE OF THIS TRAINING  
MODULE IS TO INFORM  
ARMY AVIATION LEADERS  
OF  
FACTORS INVOLVED IN  
RECENT KOREA ACCIDENTS  
AND PREVENTION  
MEASURES**

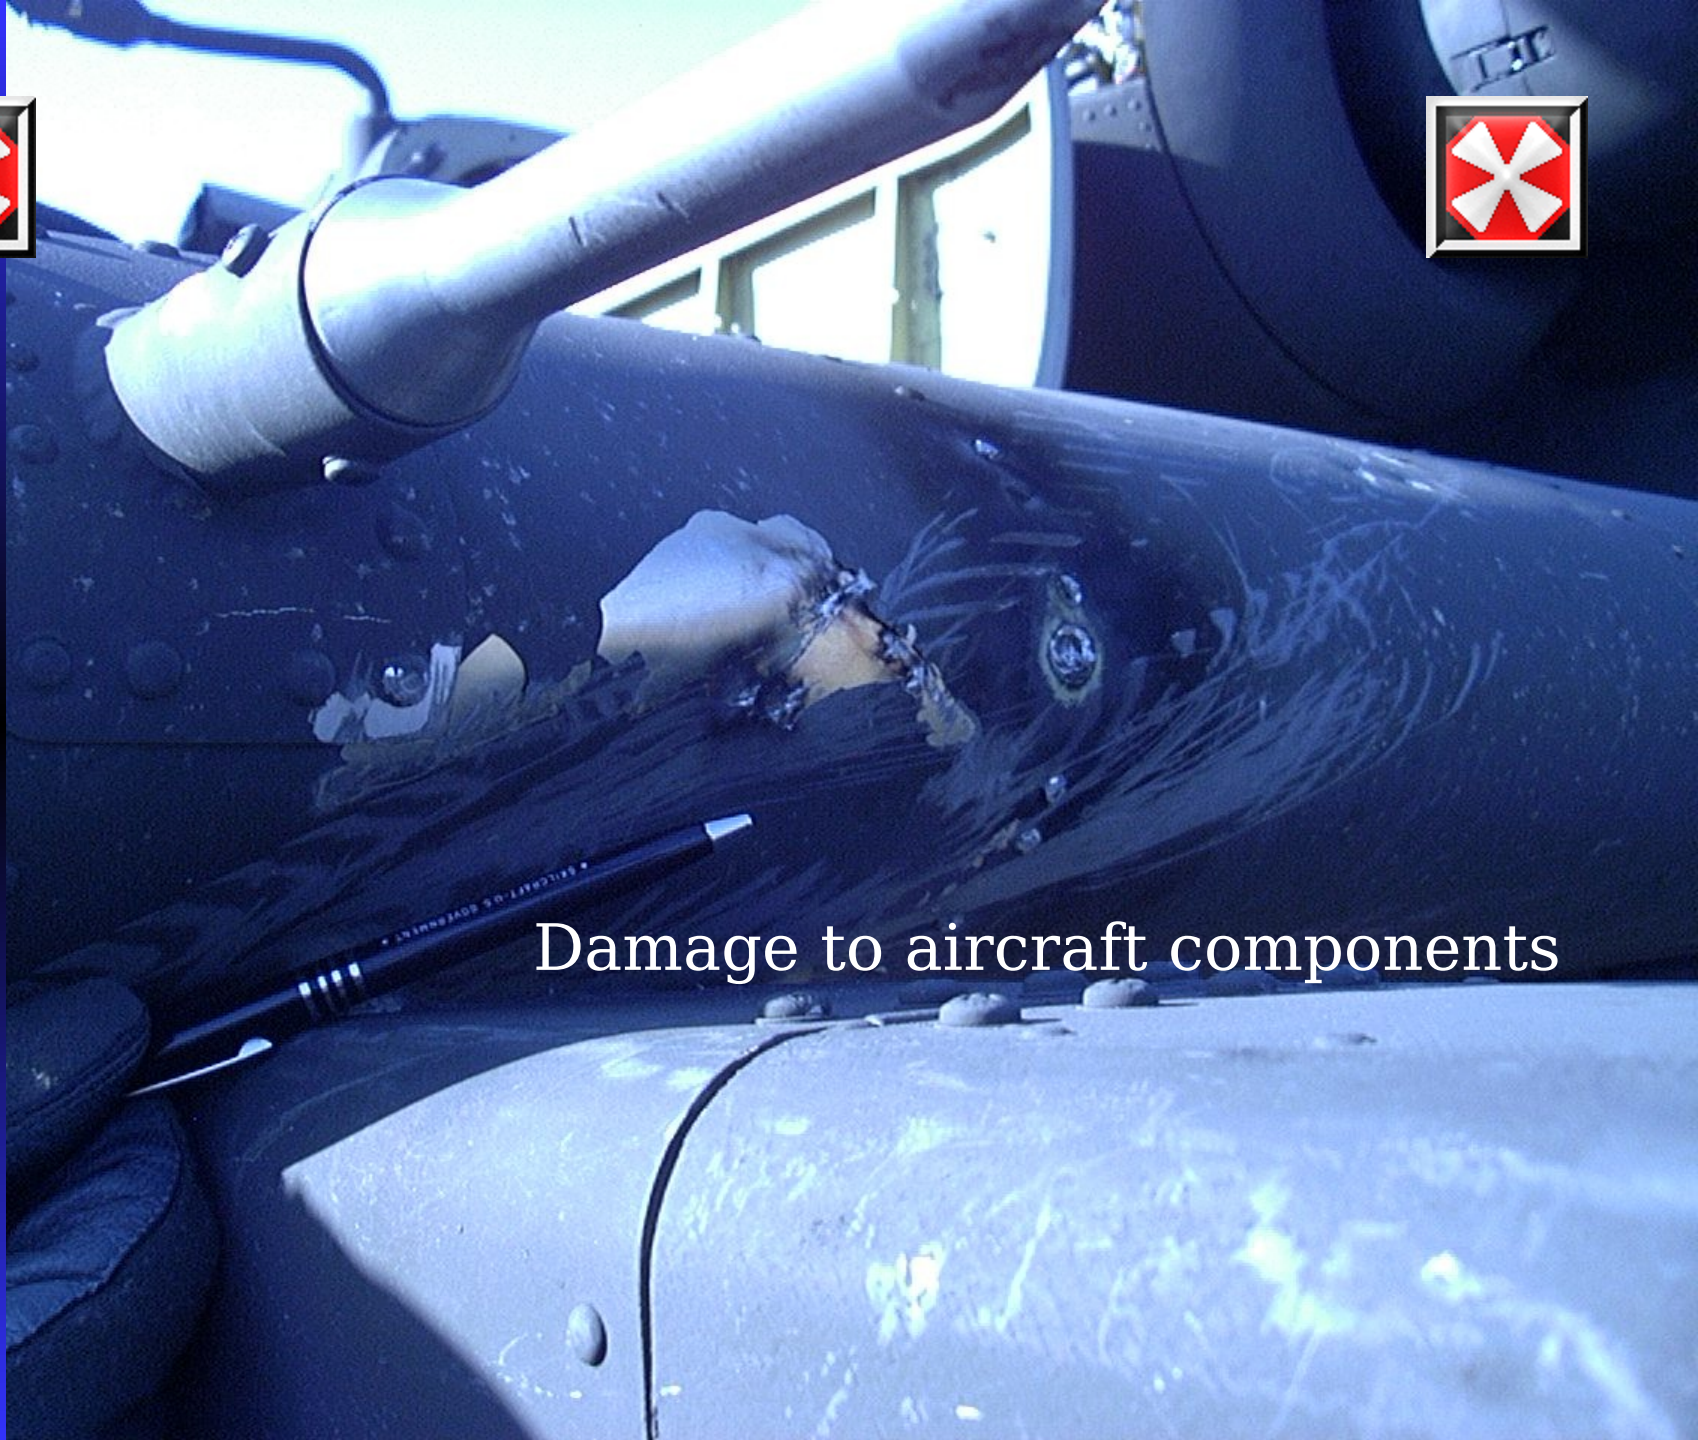
Damage to aircraft components

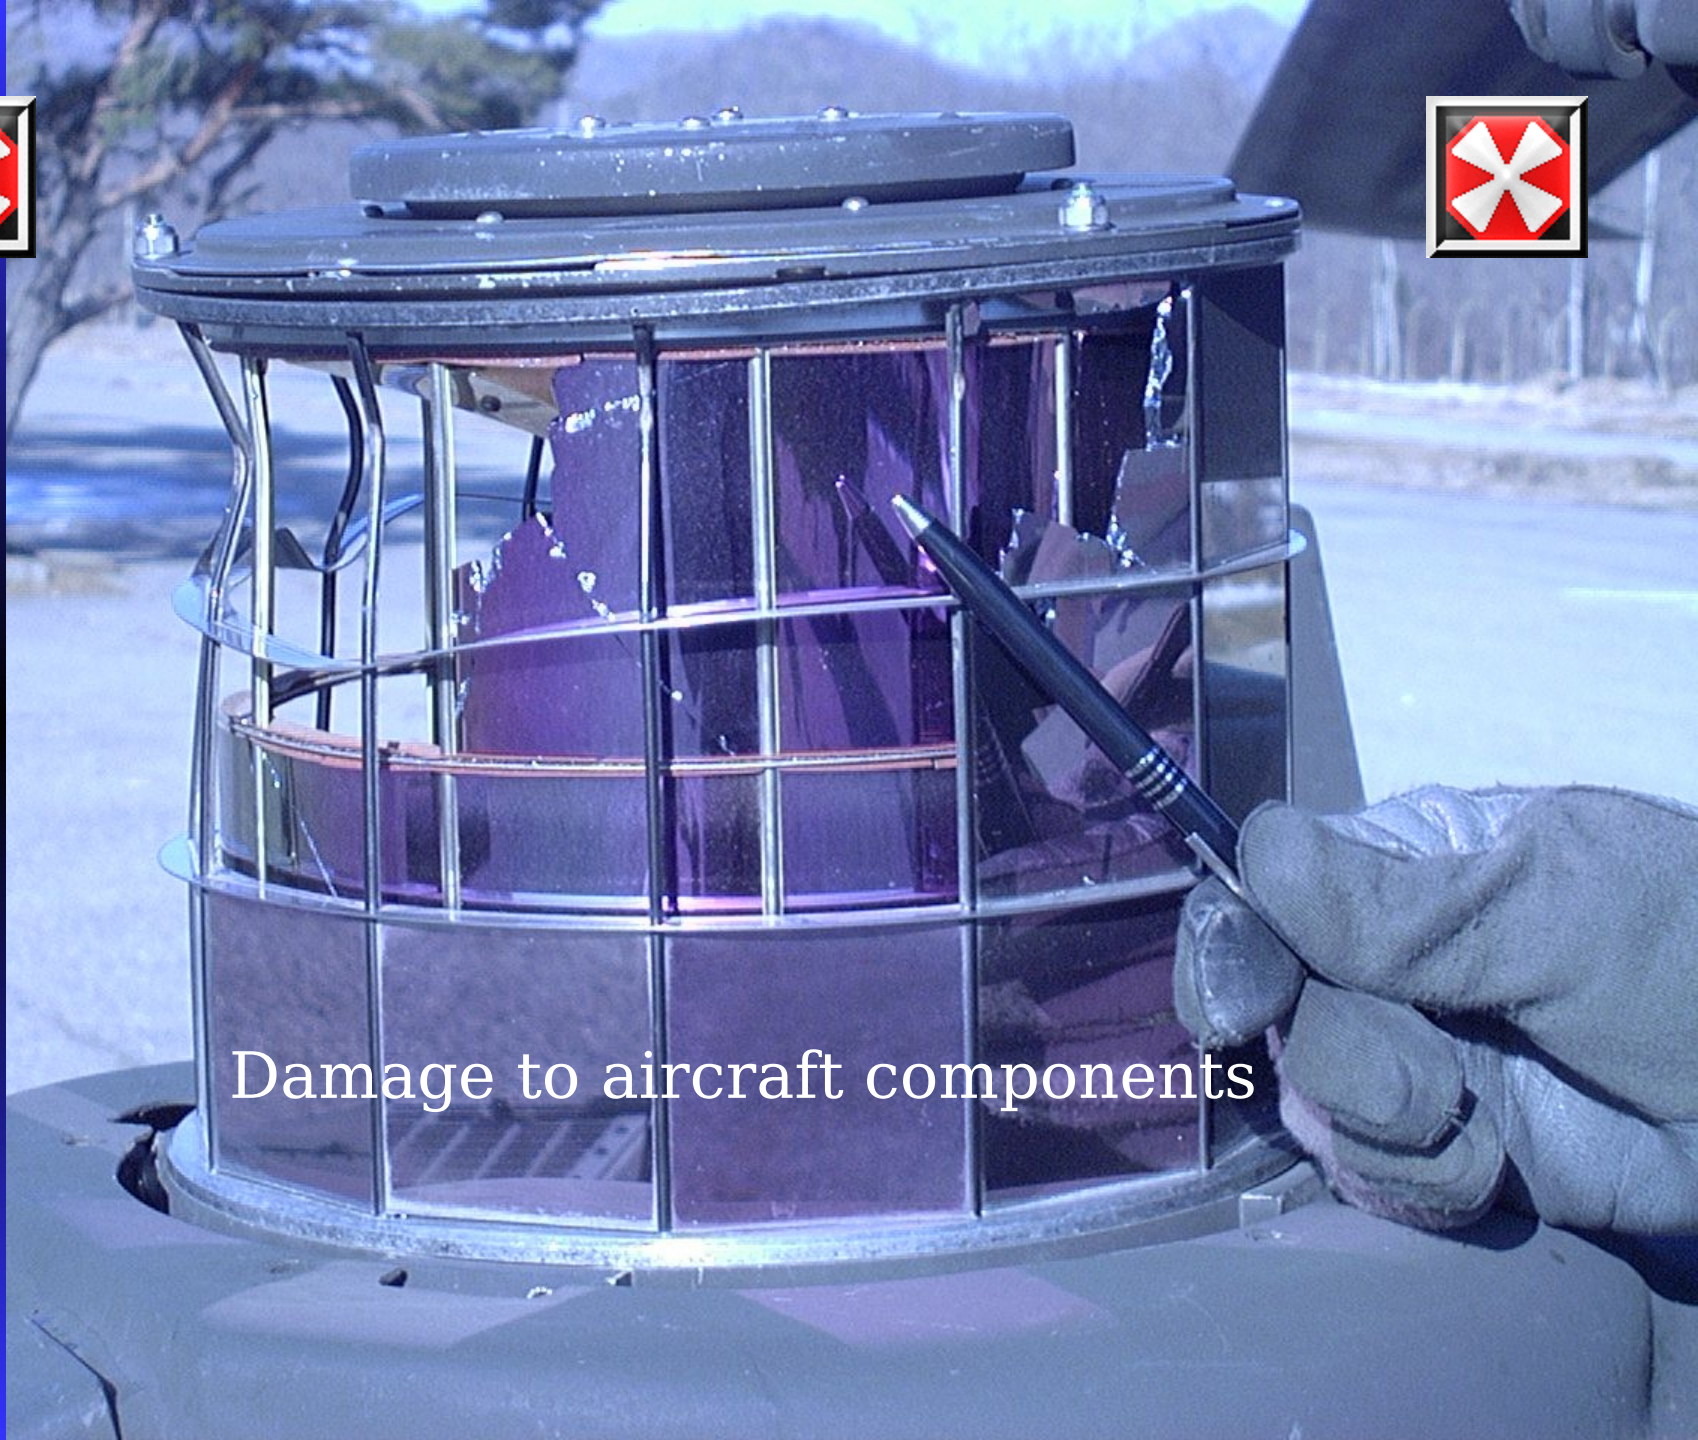
Damage to aircraft components

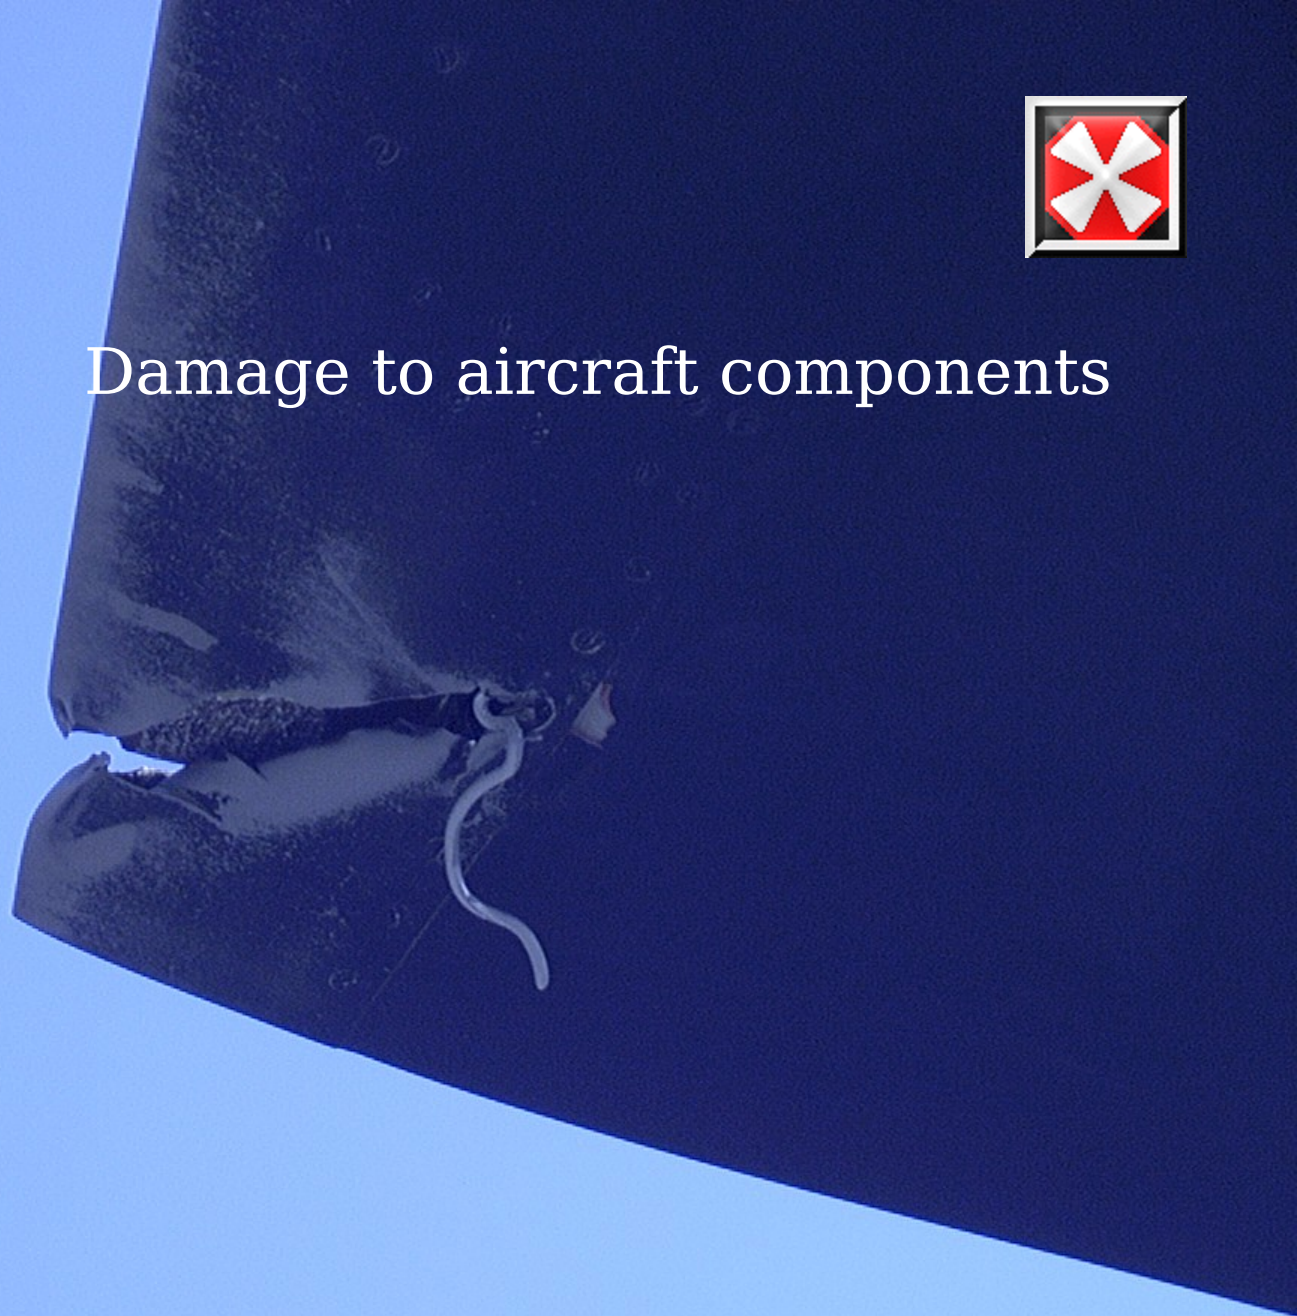
## Damage to aircraft components

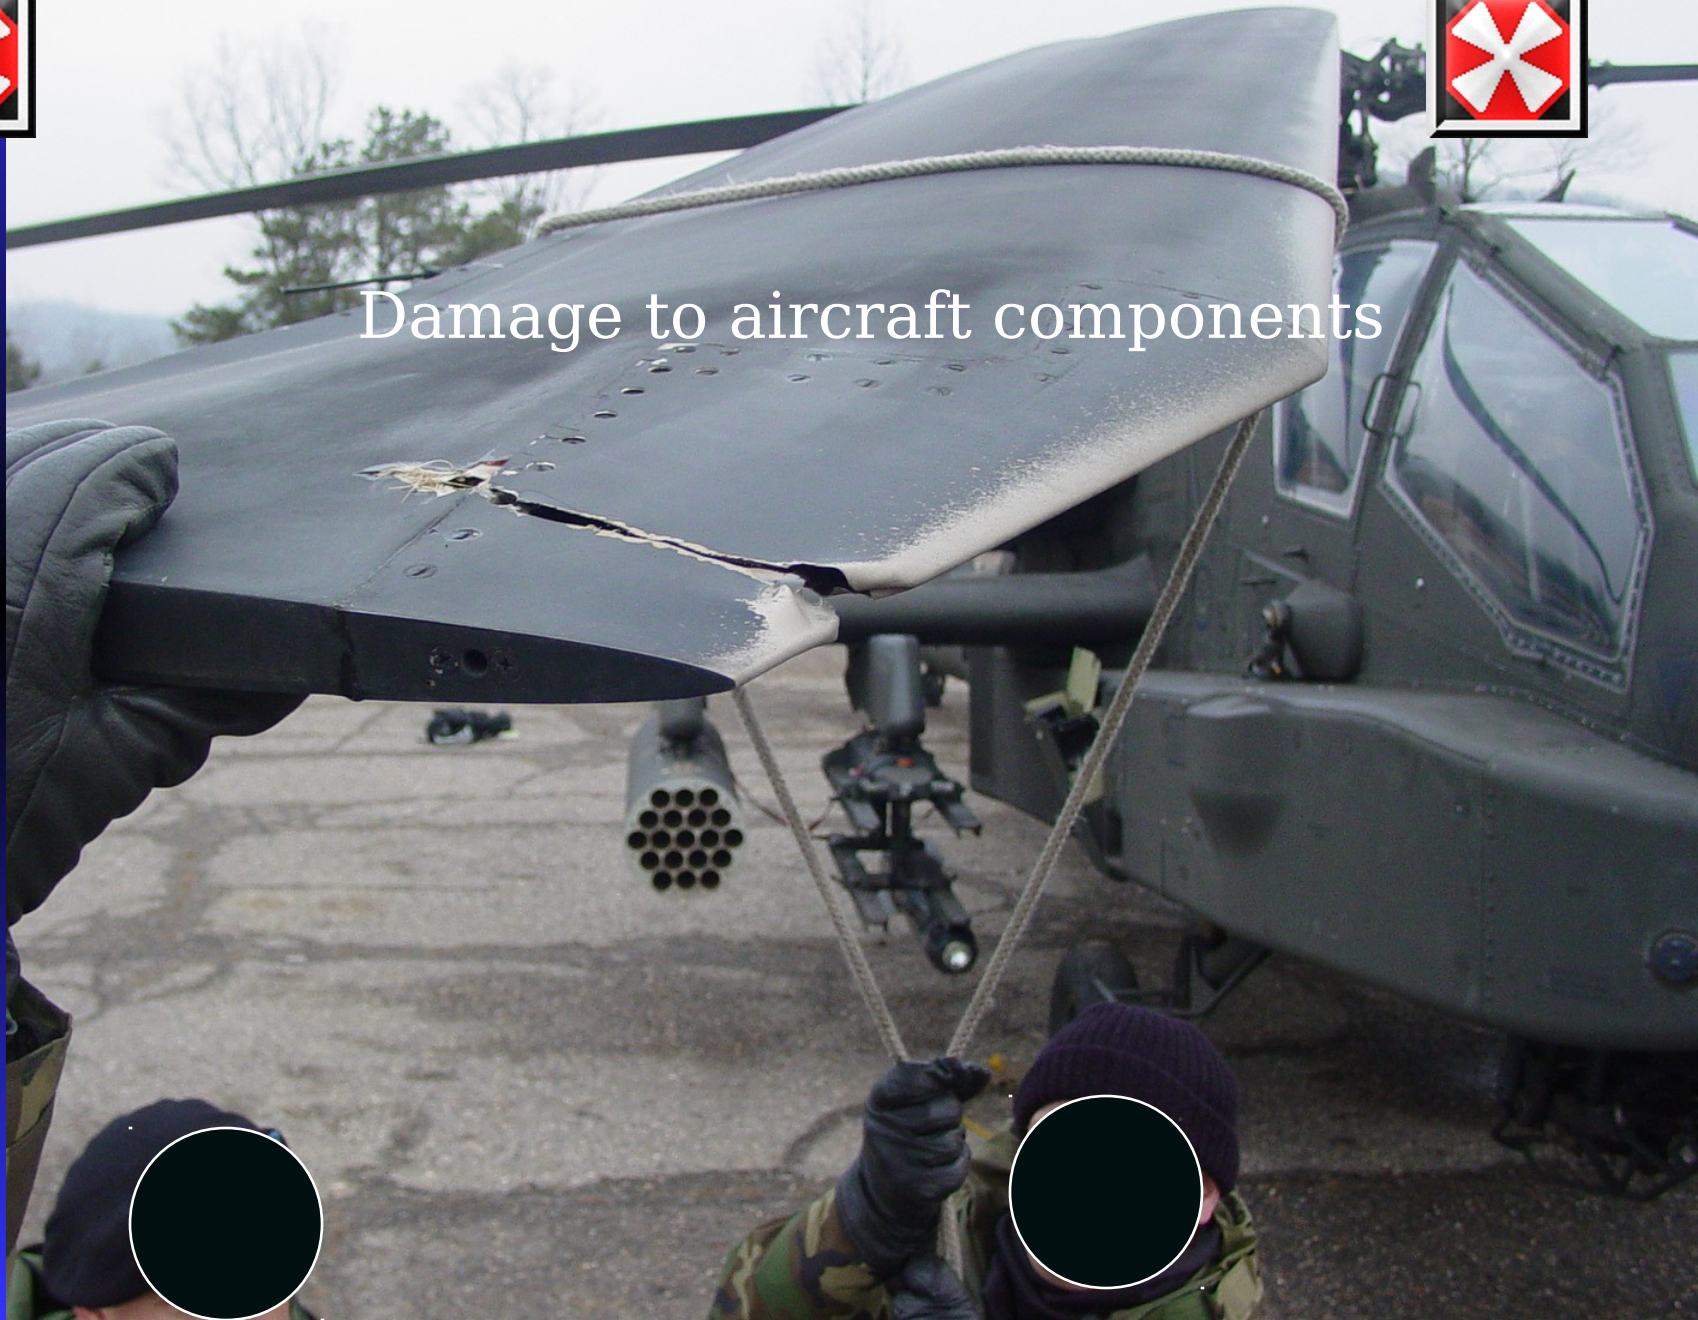
Damage to aircraft components

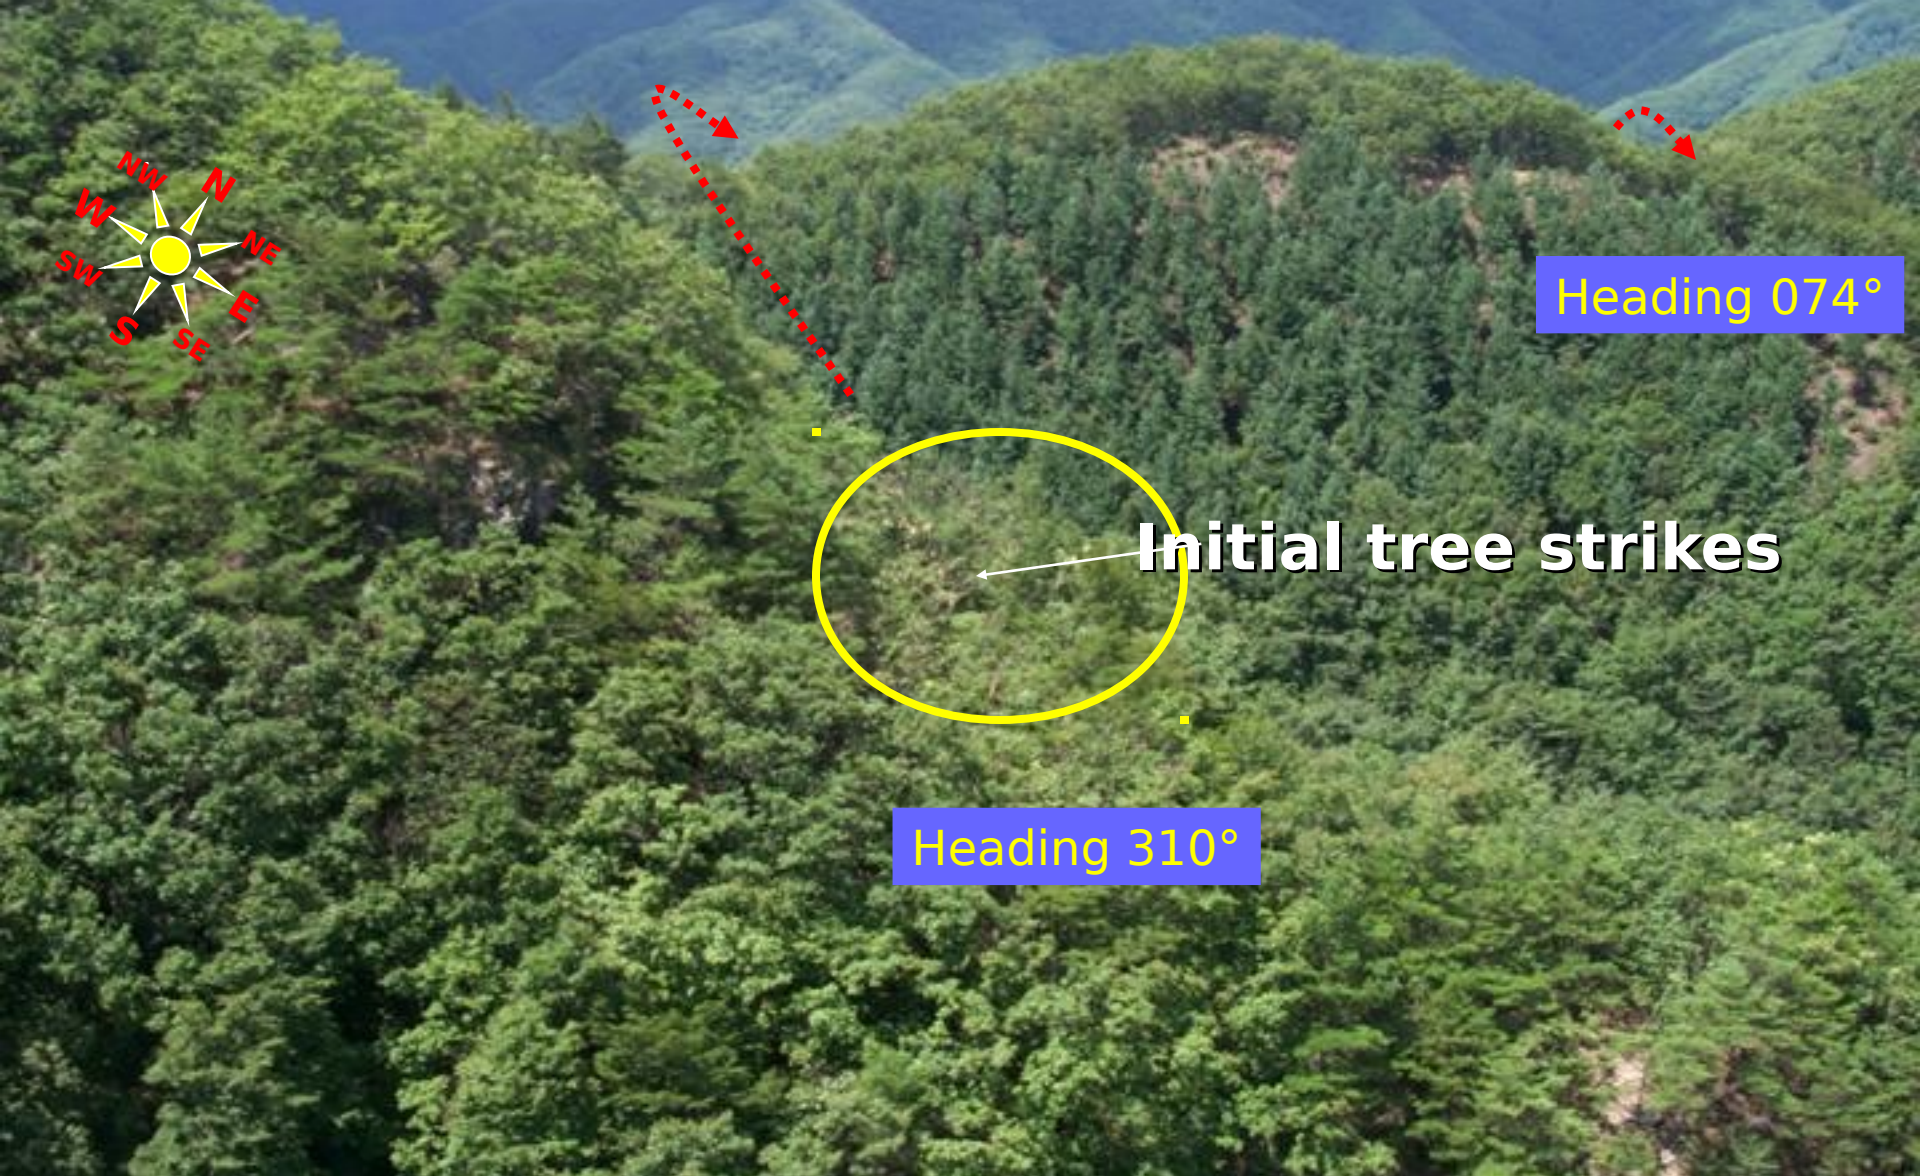
**Aerial view looking at initial tree strikes and subsequent flight path.**

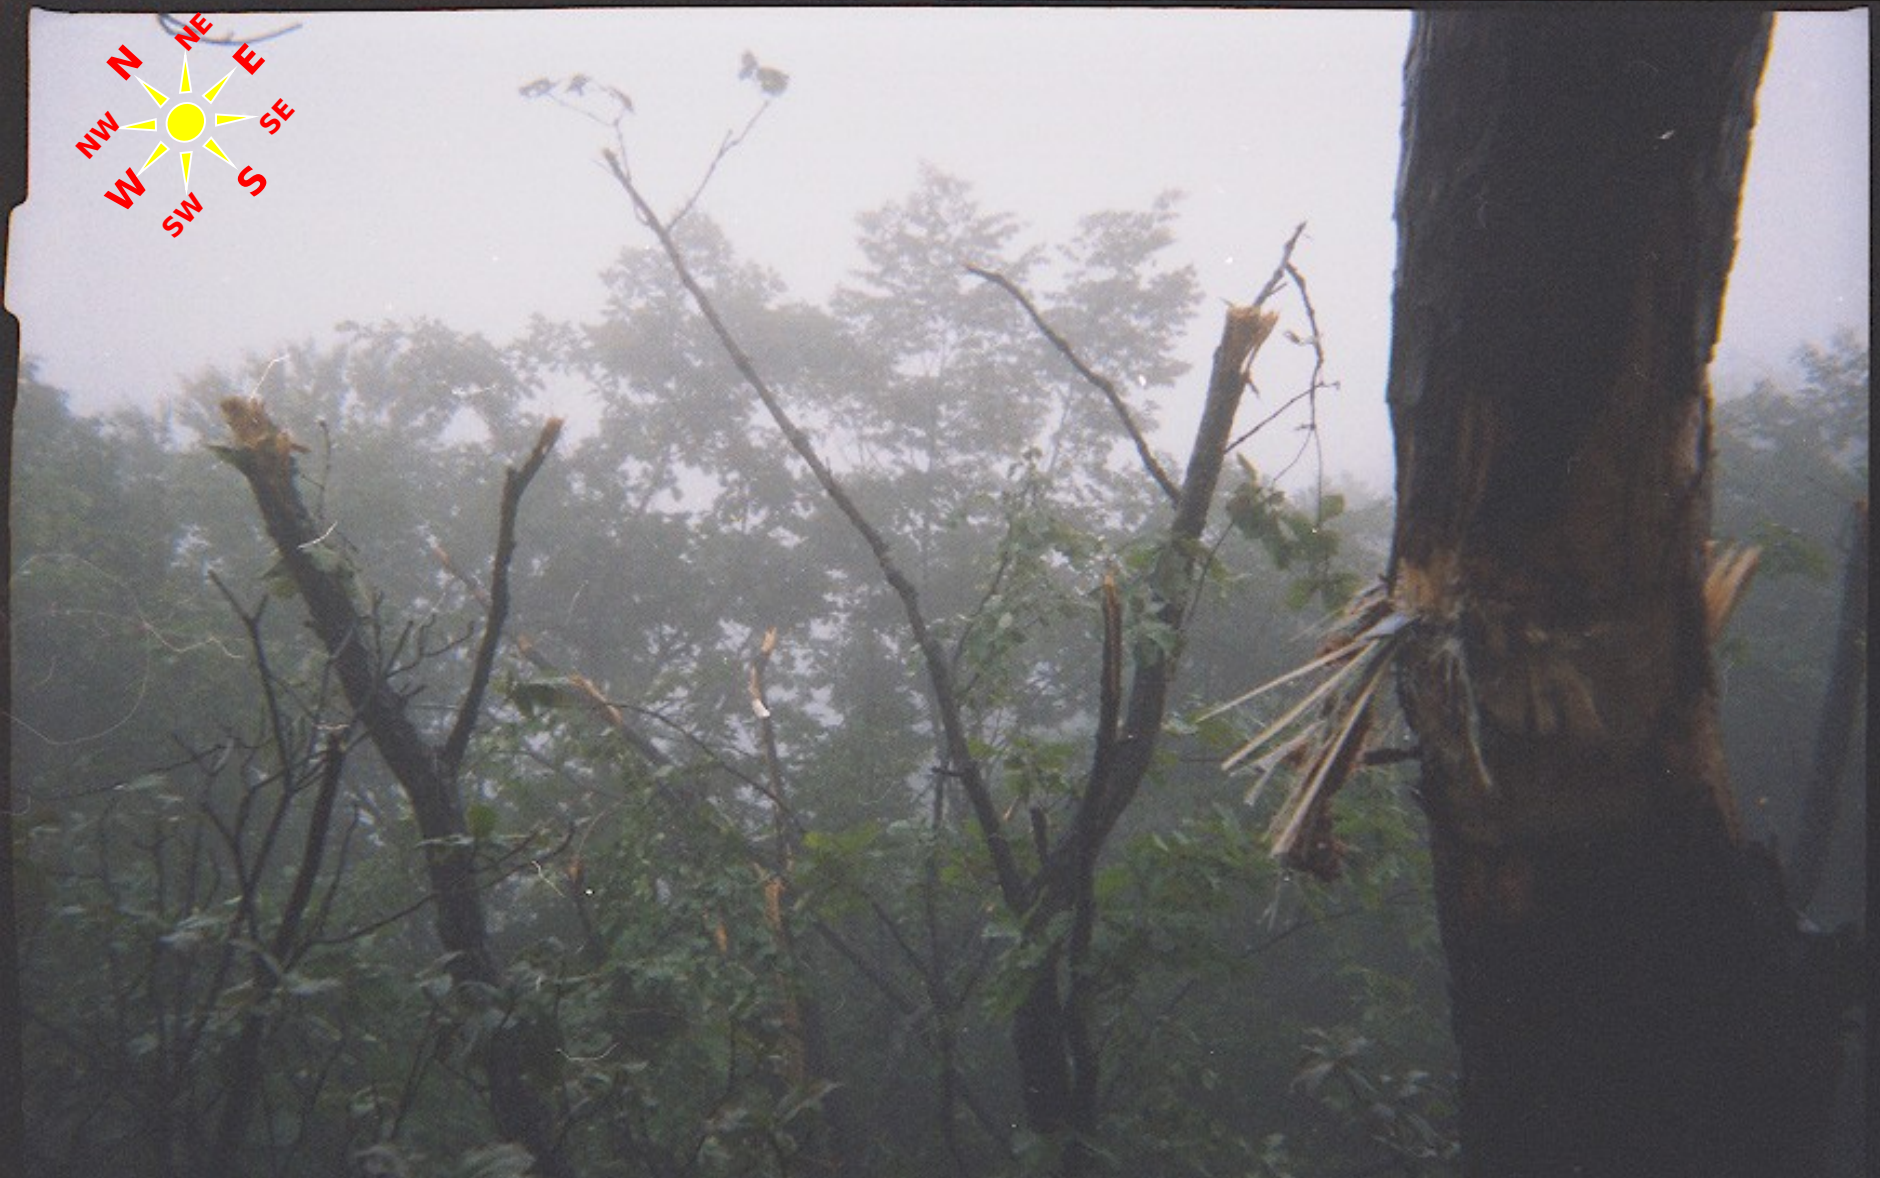
**Ground view of initial tree strikes.**

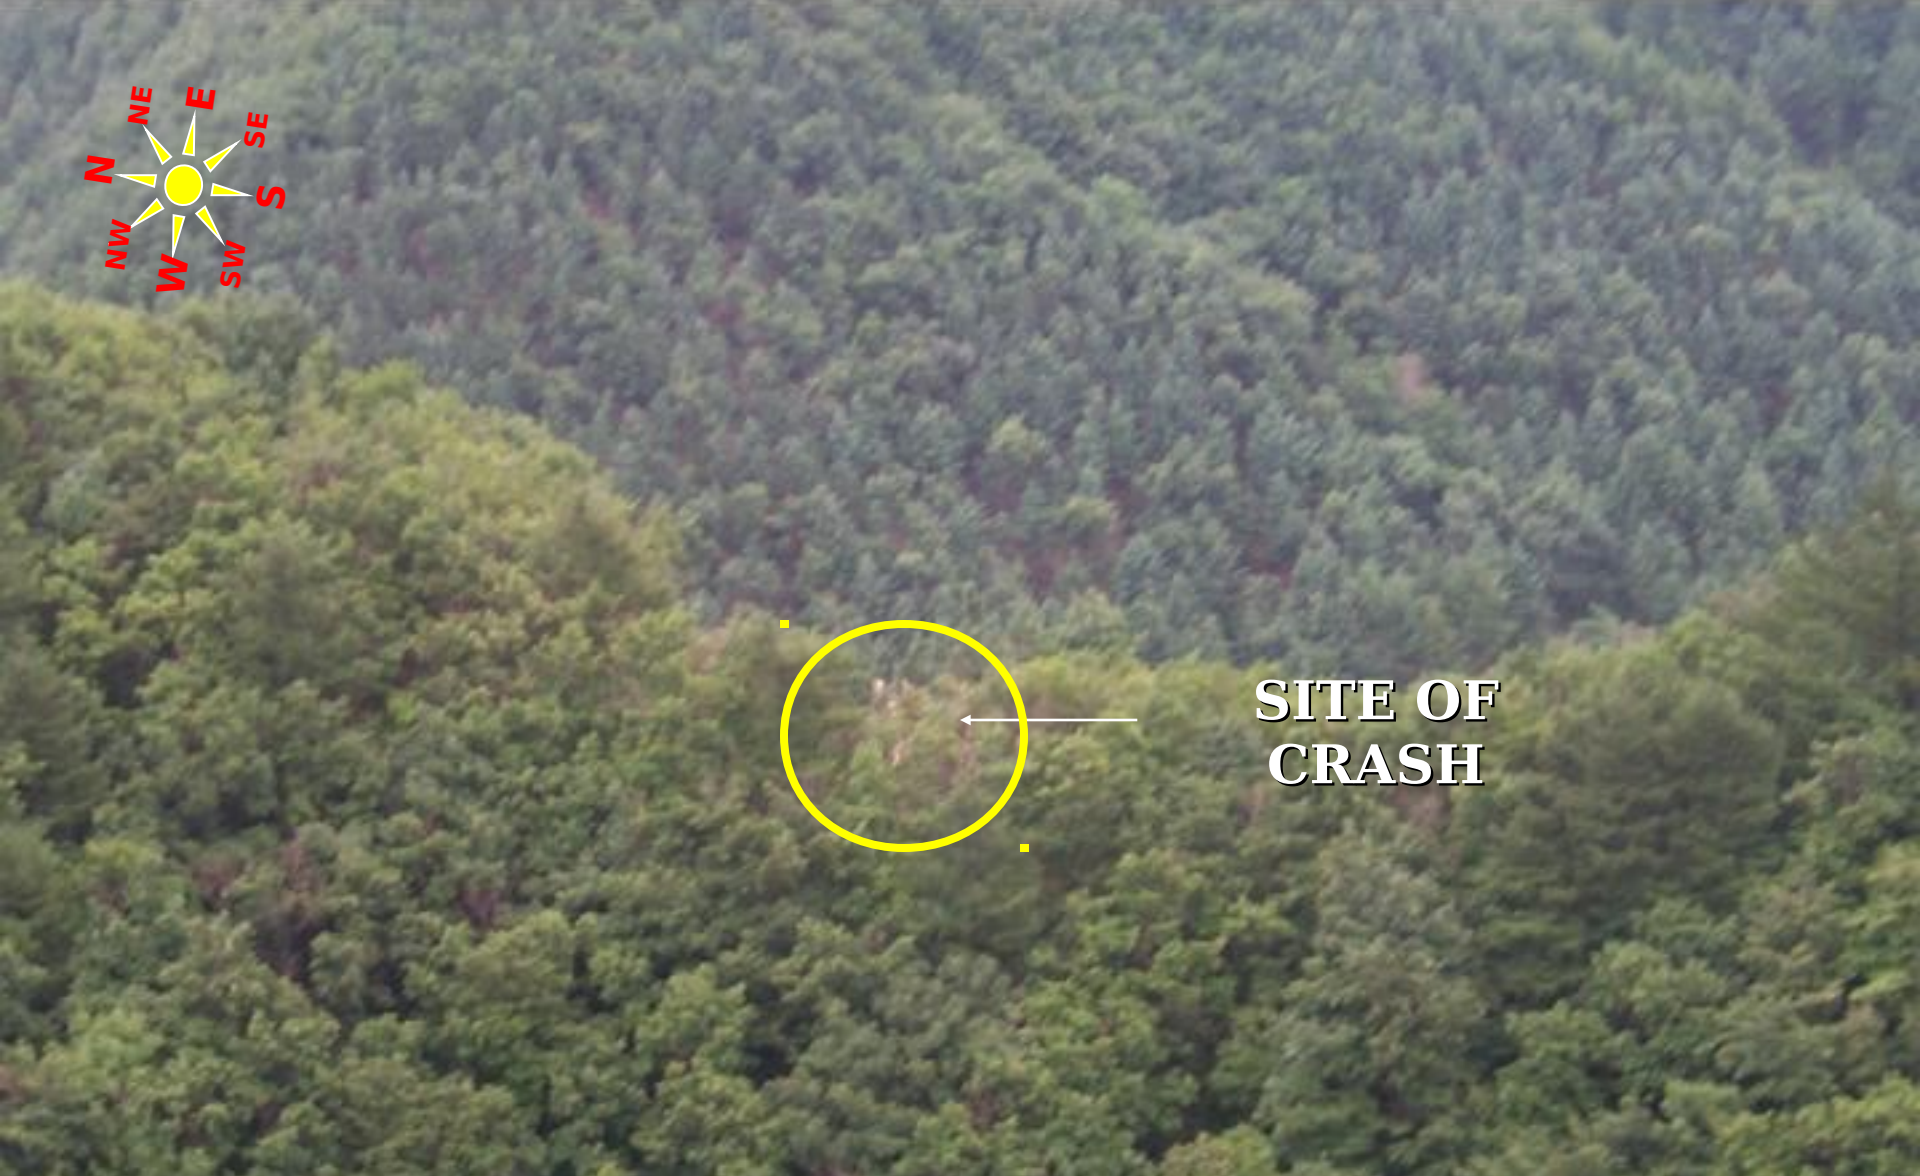
**SITE OF  
CRASH**

**erial view looking at the approach path at the crash site  
Approach heading is 074°**

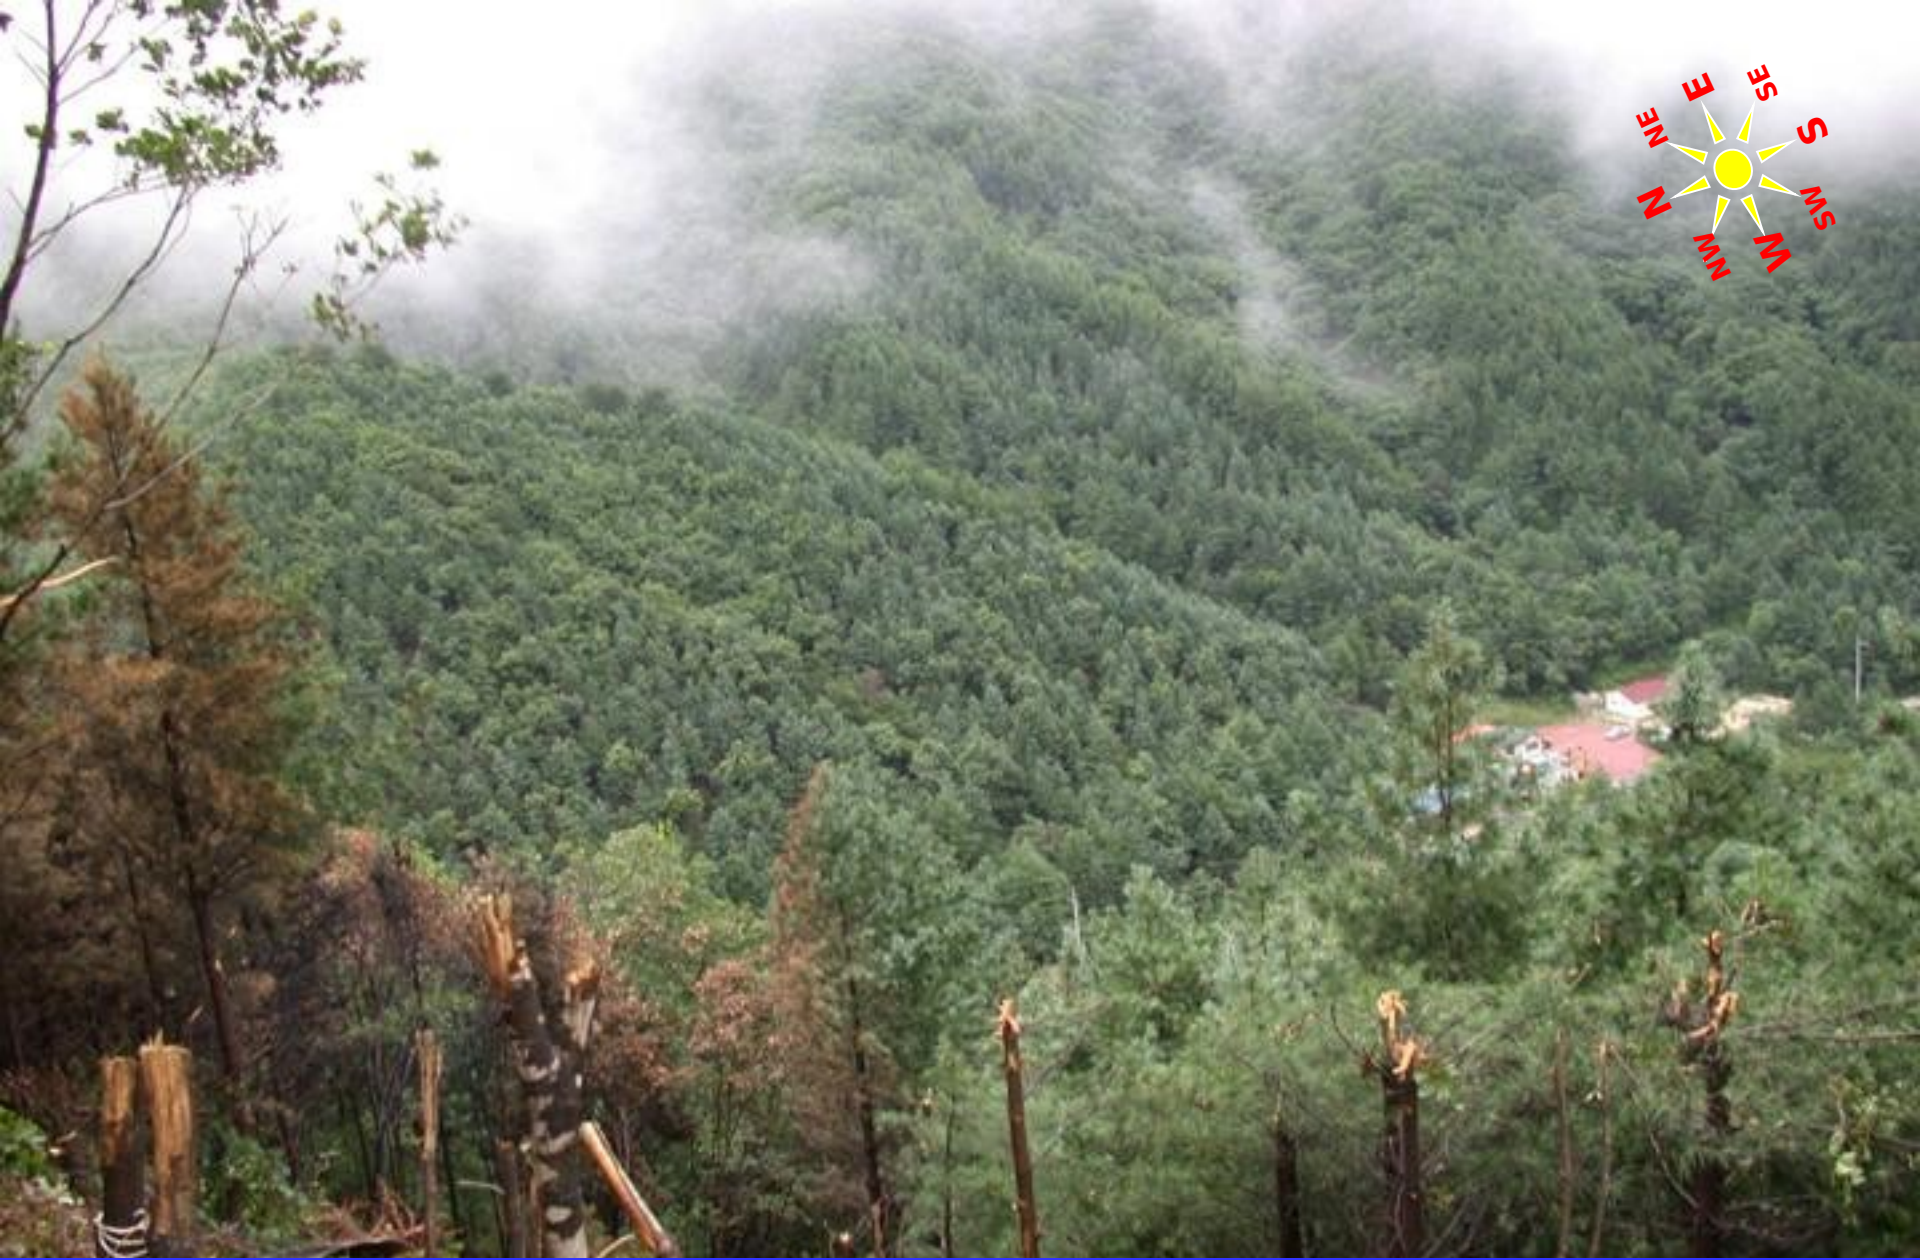
**Ground view looking down the flight path .**

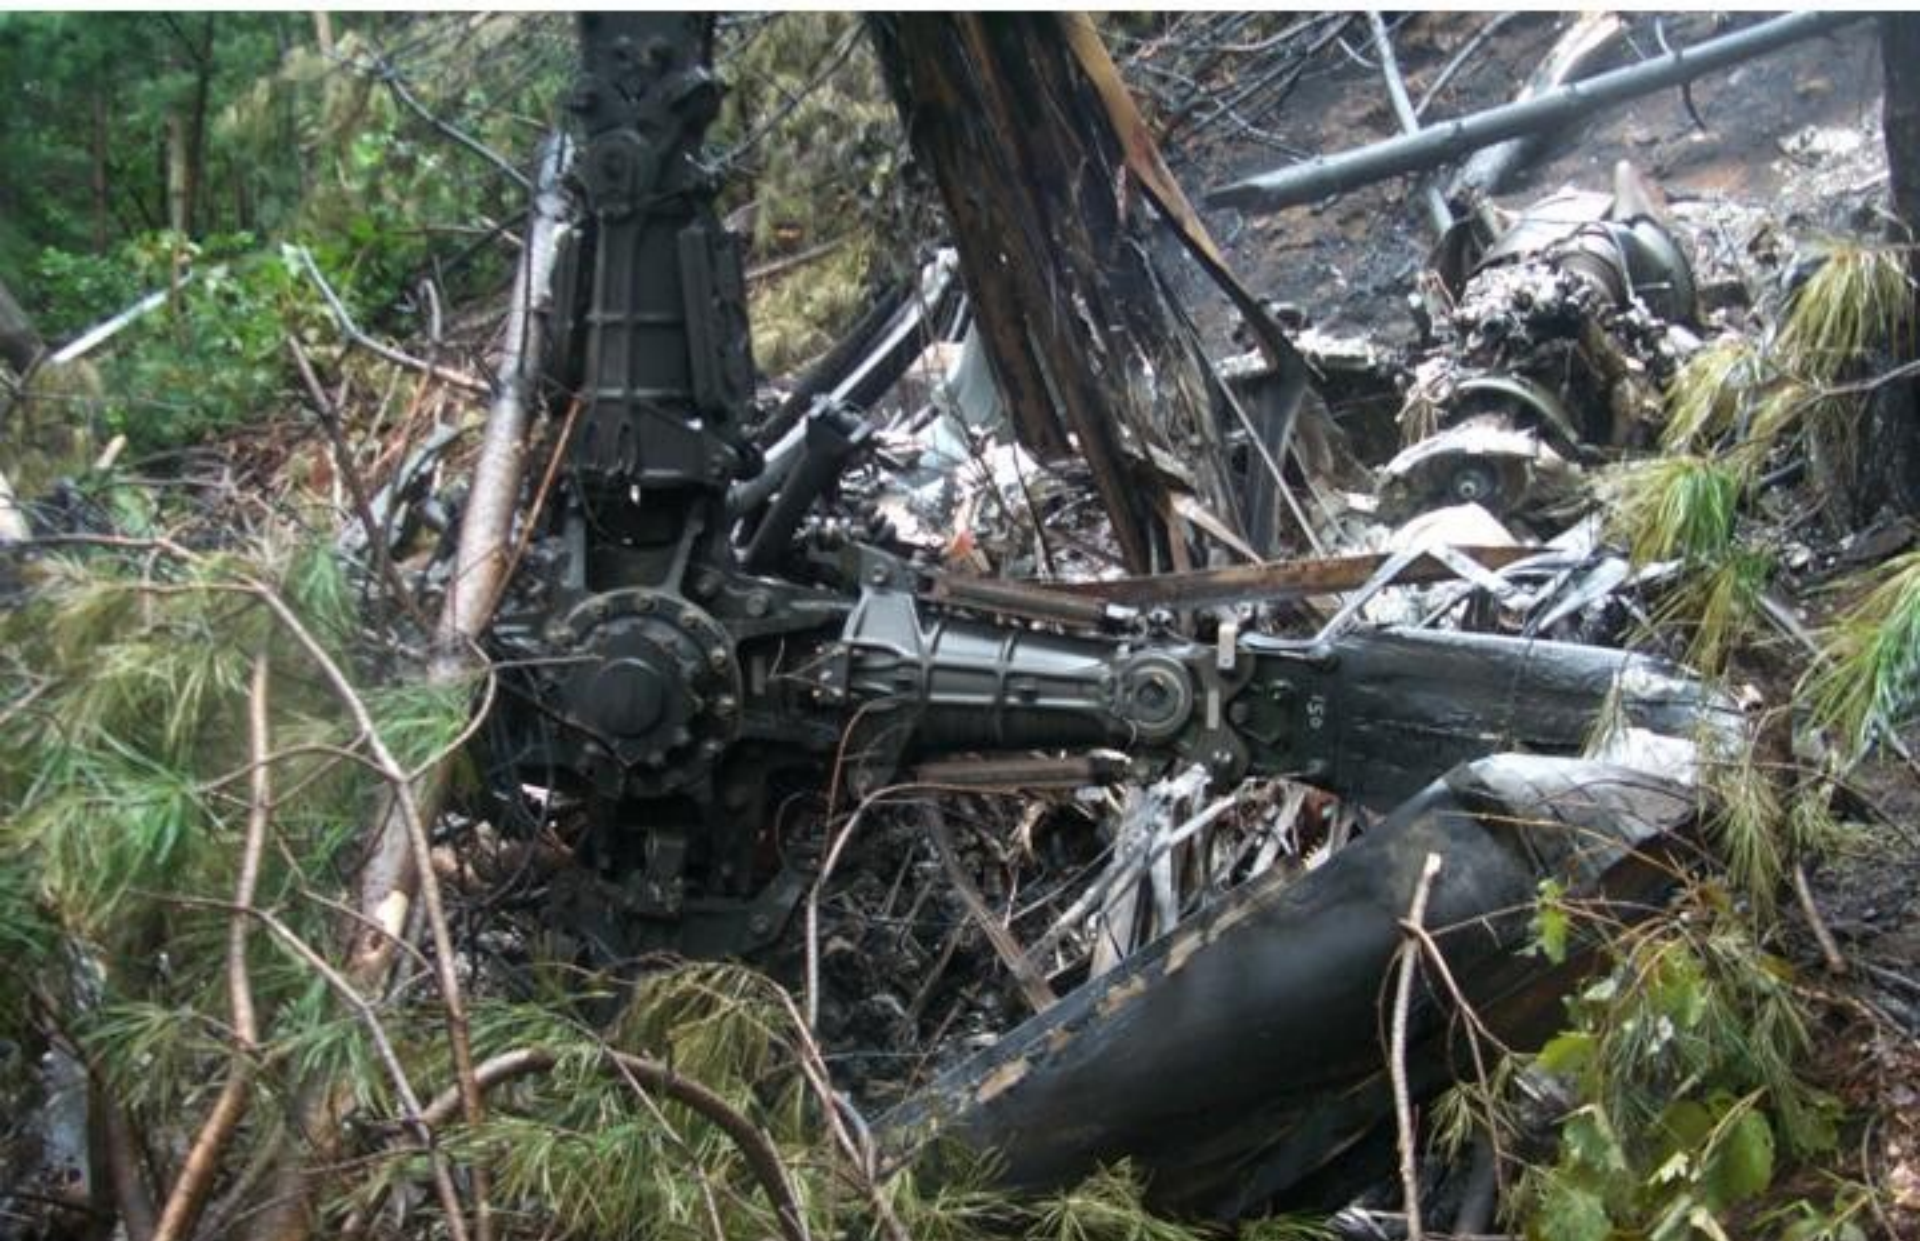
of aircraft wreckage. Aircraft was destroyed by post  
e that started from the 230 gallon ERFs tank rupturing

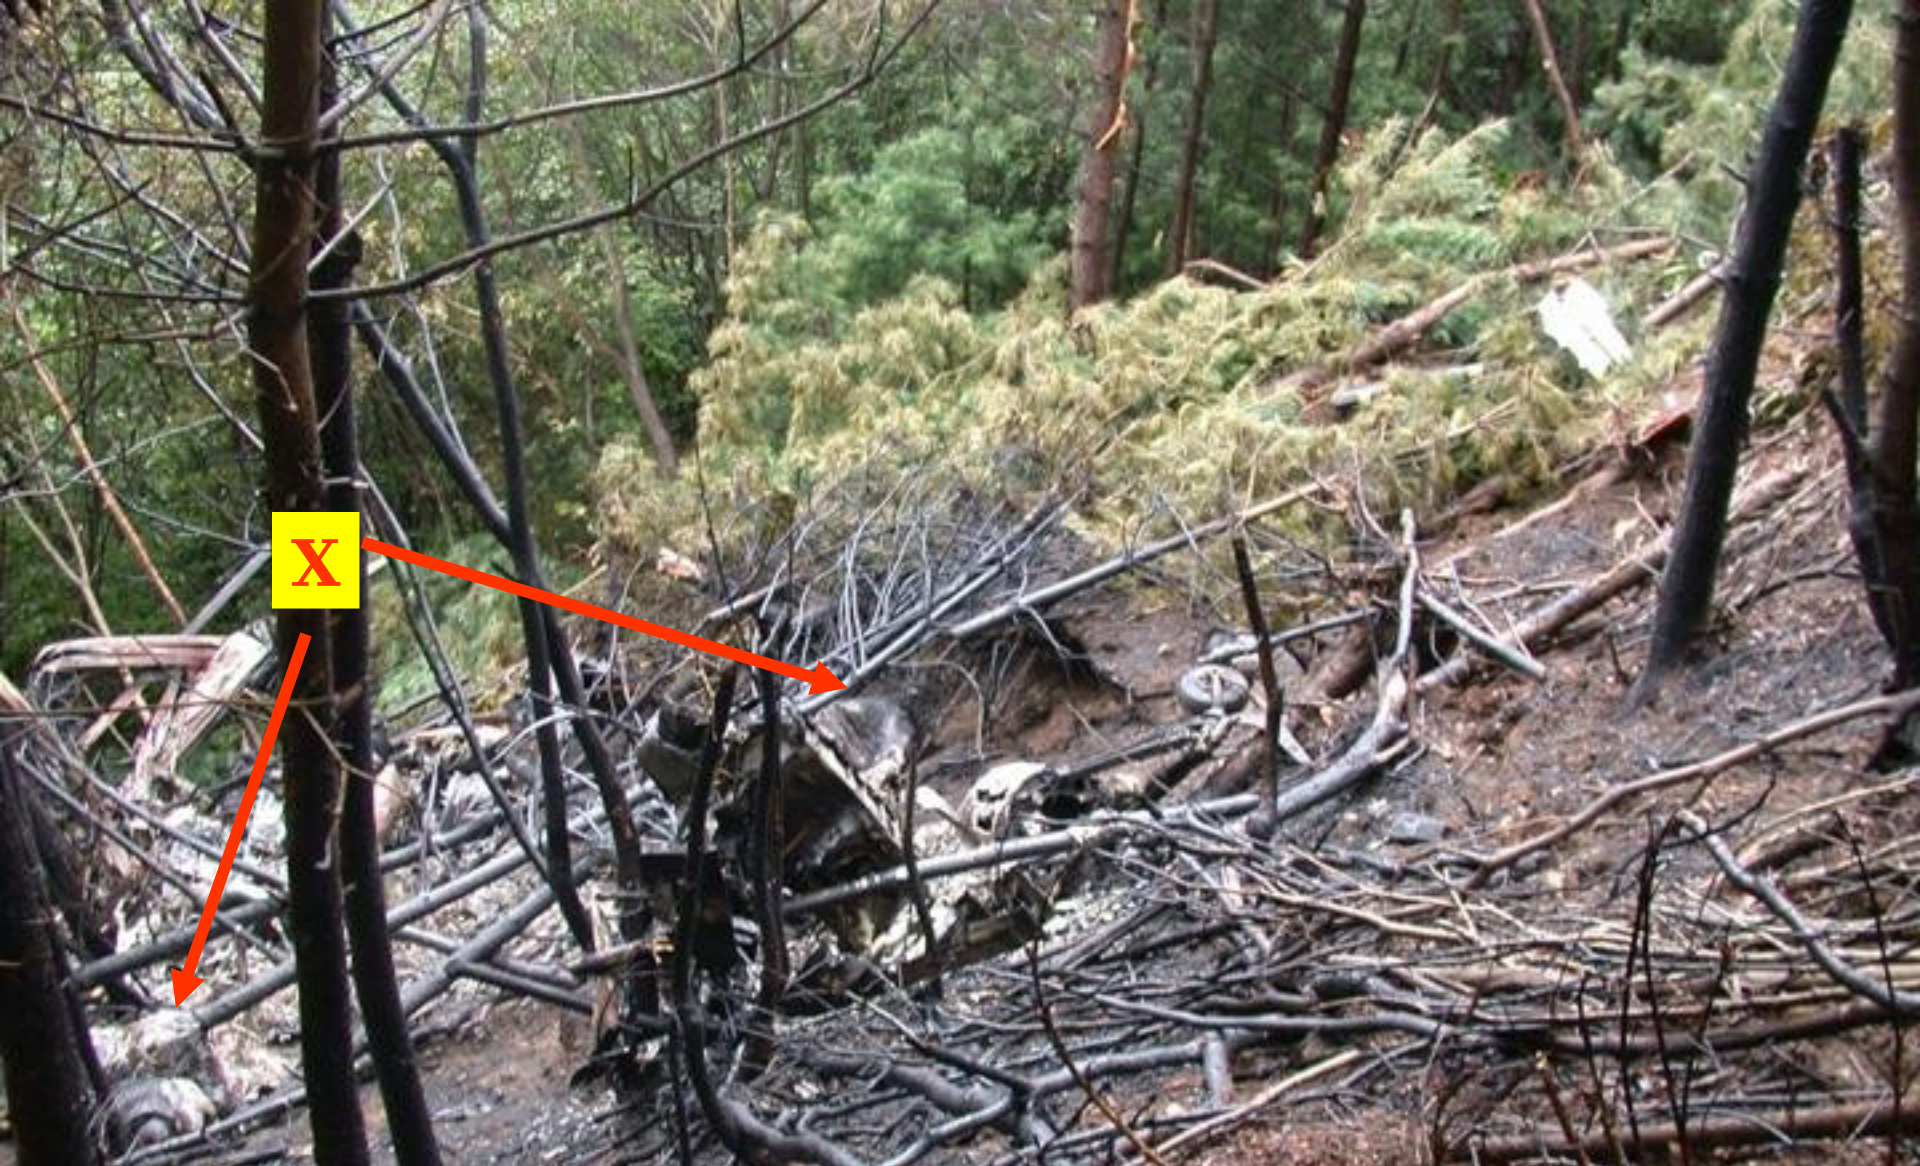
**Profile view of crash site. “X” denotes remains of 230 gallon external tank. Ground slope at crash site is approximately  $70^\circ$  Wreckage is 68 yards from the top of the saddle**
